HWY-11-MH-012  
Truck Trailer - Amtrak Train Collision  
Miriam, NV  
June 24, 2011

**TRACTOR-TRAILER HIGHWAY/RAIL GRADE CROSSING COLLISION STRIKING  
AMTRAK PASSENGER TRAIN**

**Miriam, Nevada**

**SIGNAL GROUP FACTUAL REPORT**

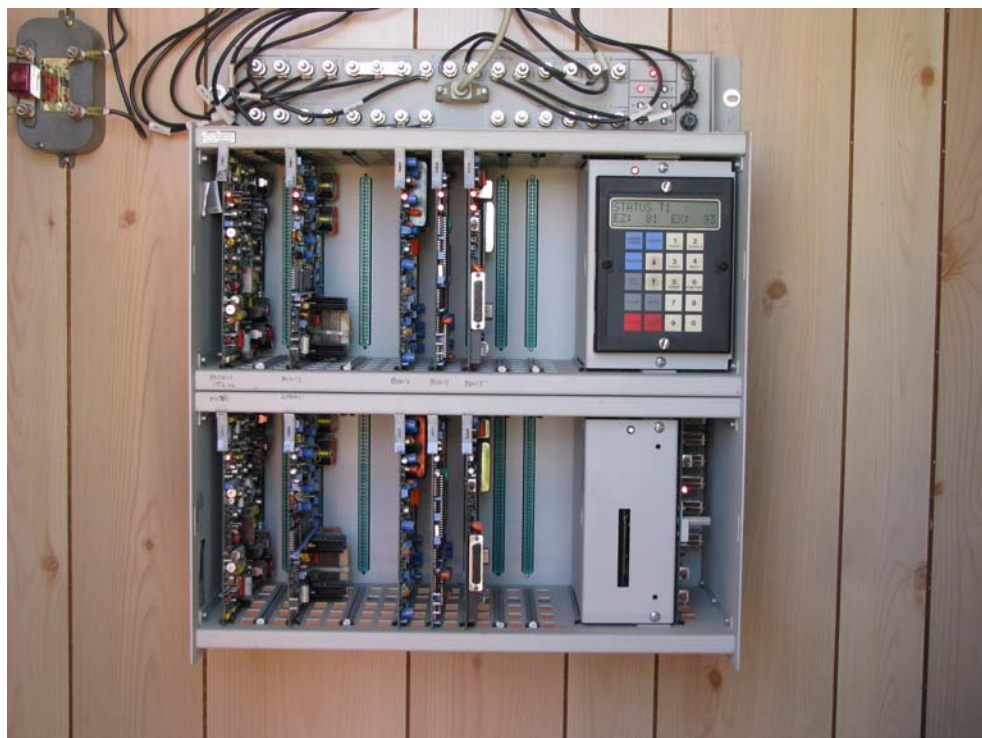
Exemplar train detection data for a GCP-3000 unit was obtained from the Lovelock Yard grade crossing at MP 343.8 and from a HCA unit from a crossing in Walthway, Nevada at MP 258.27 on the Nevada Subdivision.

**Figure 2. Exemplar GCP-3000 unit.**
